Ice Arena Survey

Fenton W. Chester Rink

145 College Road, Lyndon Center, Vermont

September 2023

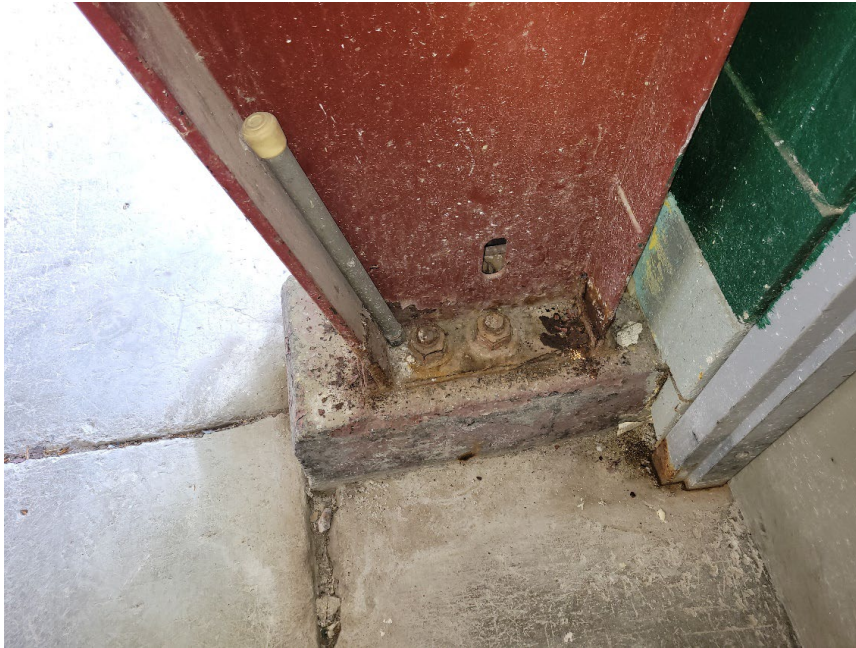
At the columns at frames 2 and 3 near the east side of the building, the baseplates and anchor bolts were showing sign of corrosion, it is recommended that these baseplates and anchor bolts be sandblasted or wire brushed to bare metal and treated with zinc rich compound. If after sand blasting significant loss of section is apparent, the baseplates should be reinforced.

Figure 1 - Corrosion at Base Plate of Column by Overhead Door

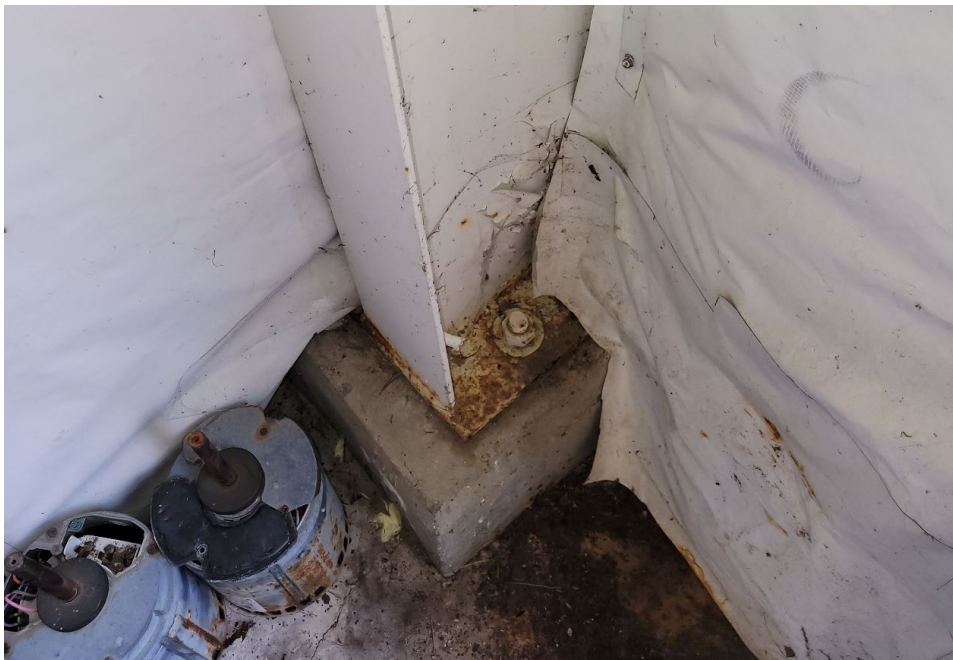
Figure 2 - Corrosion at Base of Gable Column by Overhead Door

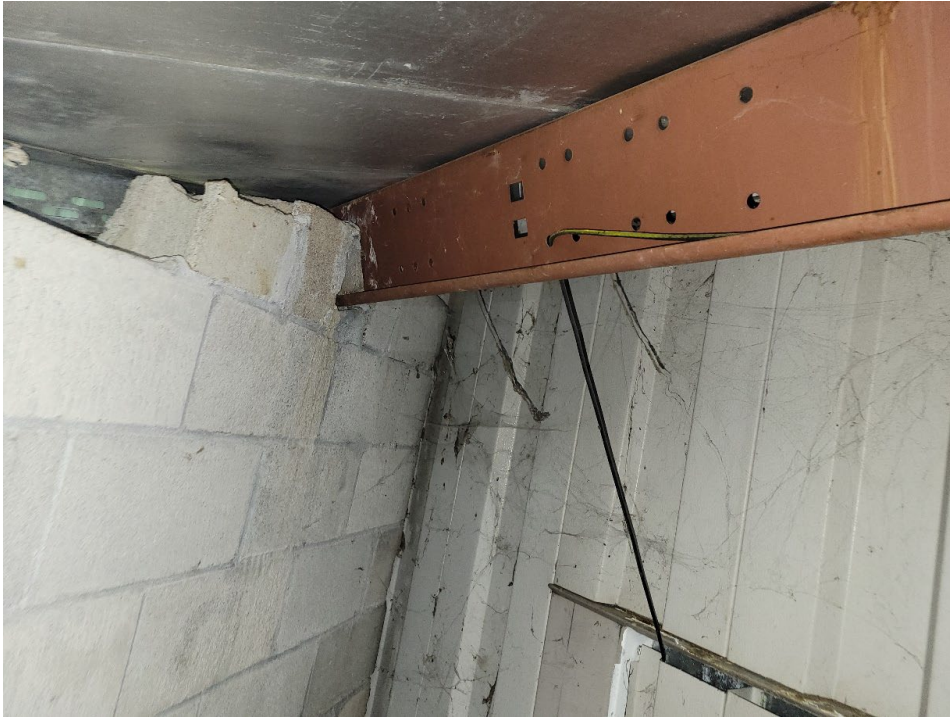
The CMU bearing wall located at the southeast side of the building at locker room D did not have proper bearing at the location where the z-purlins were supported on the CMU wall. In these locations it appeared that the z-purlins had rotated or the CMU wall had been damaged. We recommend that repair include the installation of bearing plates and recommend that the top of the CMU walls be repaired/replaced.

Figure 3 – Bearing of Purlins at CMU wall above Locker Room D

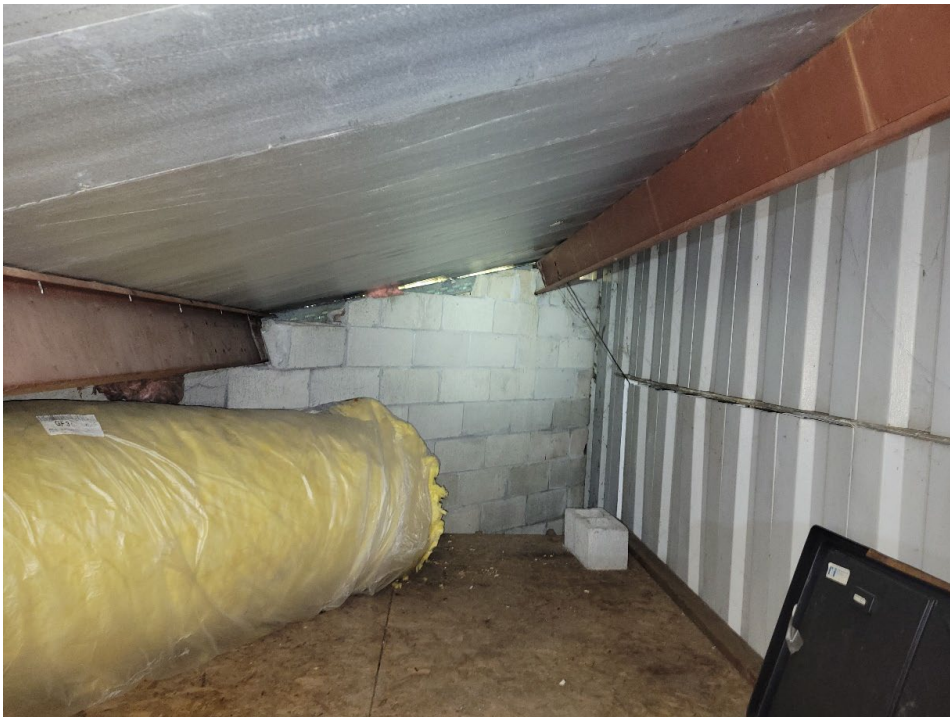
Figure 4 – Bearing of Purlins at CMU wall above Locker Room D

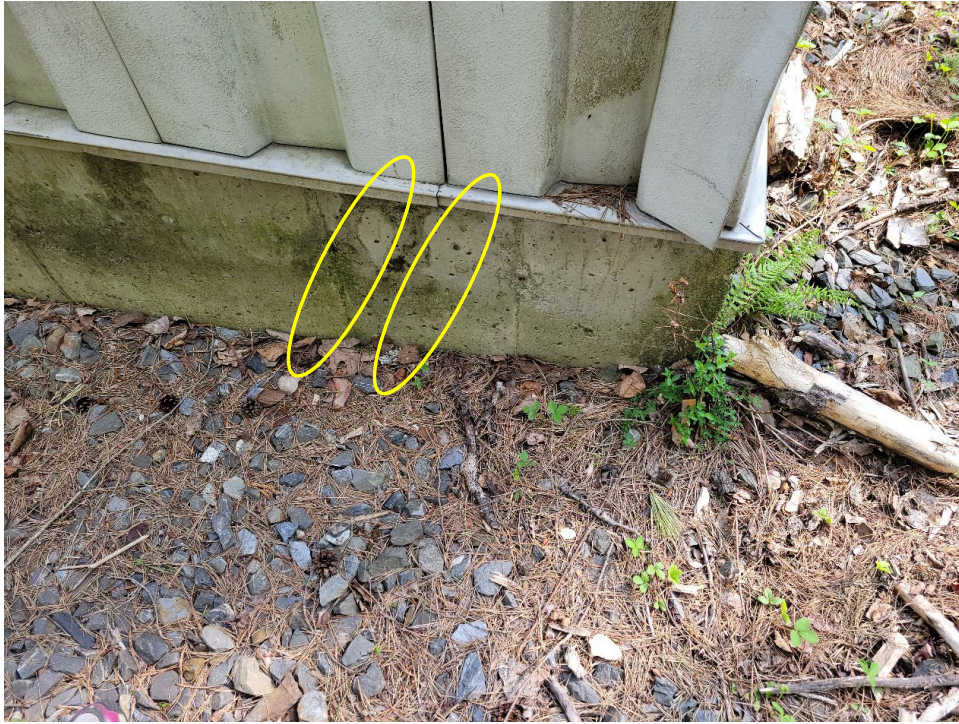
During the inspection of the foundation, there were various minor cracks in the concrete around the exterior of the building. Along the foundation at the southeast side of the building there were a few exposed form ties, indicating that originally that area of the foundation was below grade. The majority of the cracks in the wall appear to be shrinkage cracks that occur when control joints are not provided in the wall. It appears that the majority of the cracks are not structurally significant. In the areas where form ties have been exposed, we recommend that the exterior grade be raised to prevent the penetration of frost below the footing.

Figure 5 - Cracks in foundation at exterior

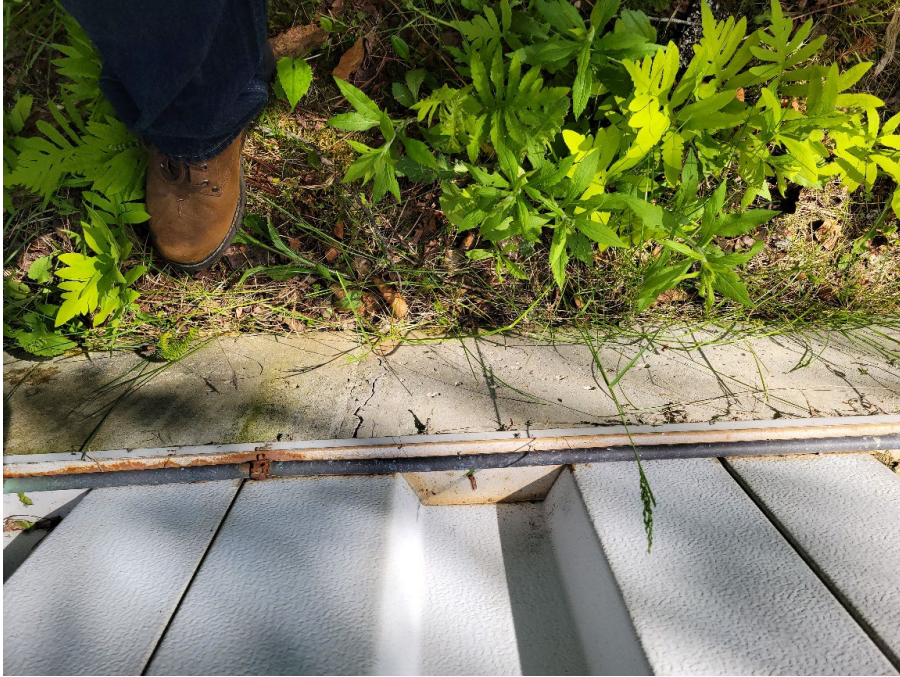
Figure 6 - Cracks in foundation at exterior

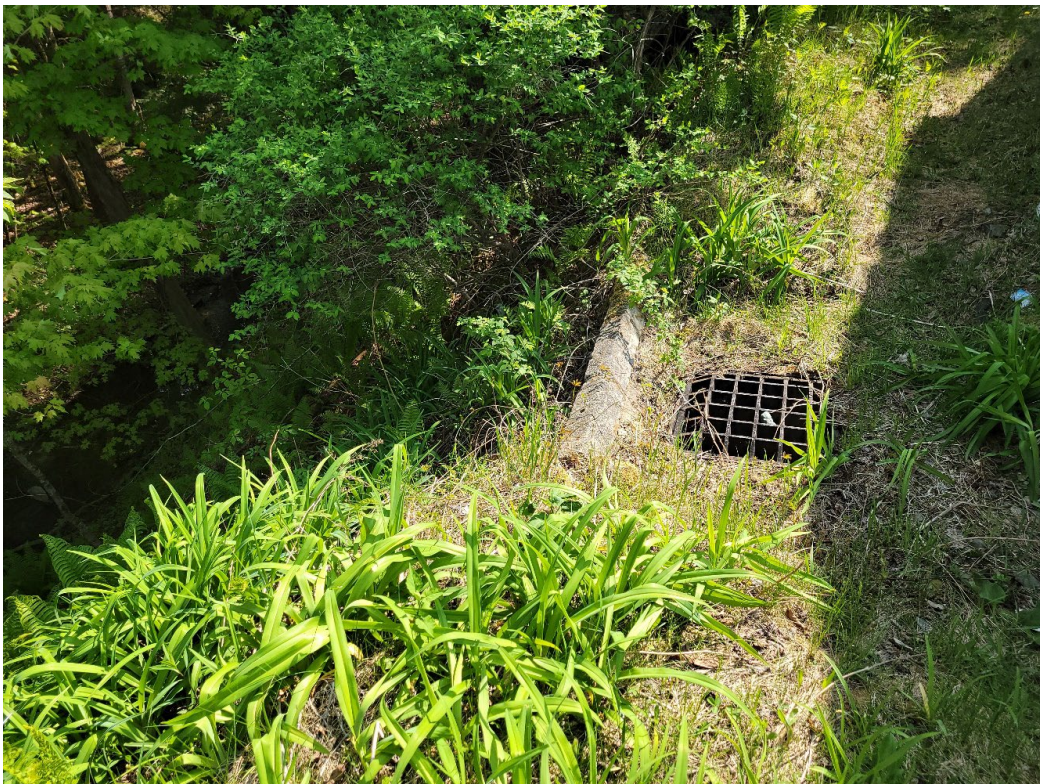
Along the west and south sides of the exterior was a steep bank with a brook running at the base of the bank. We recommend that the condition of the bank in this area be monitored as any scouring at the base of the bank could result in further steepening of the bank with the potential to cause slope stability issues under the southern end of the structure.

Figure 7- Steep embankment along south and west around exterior

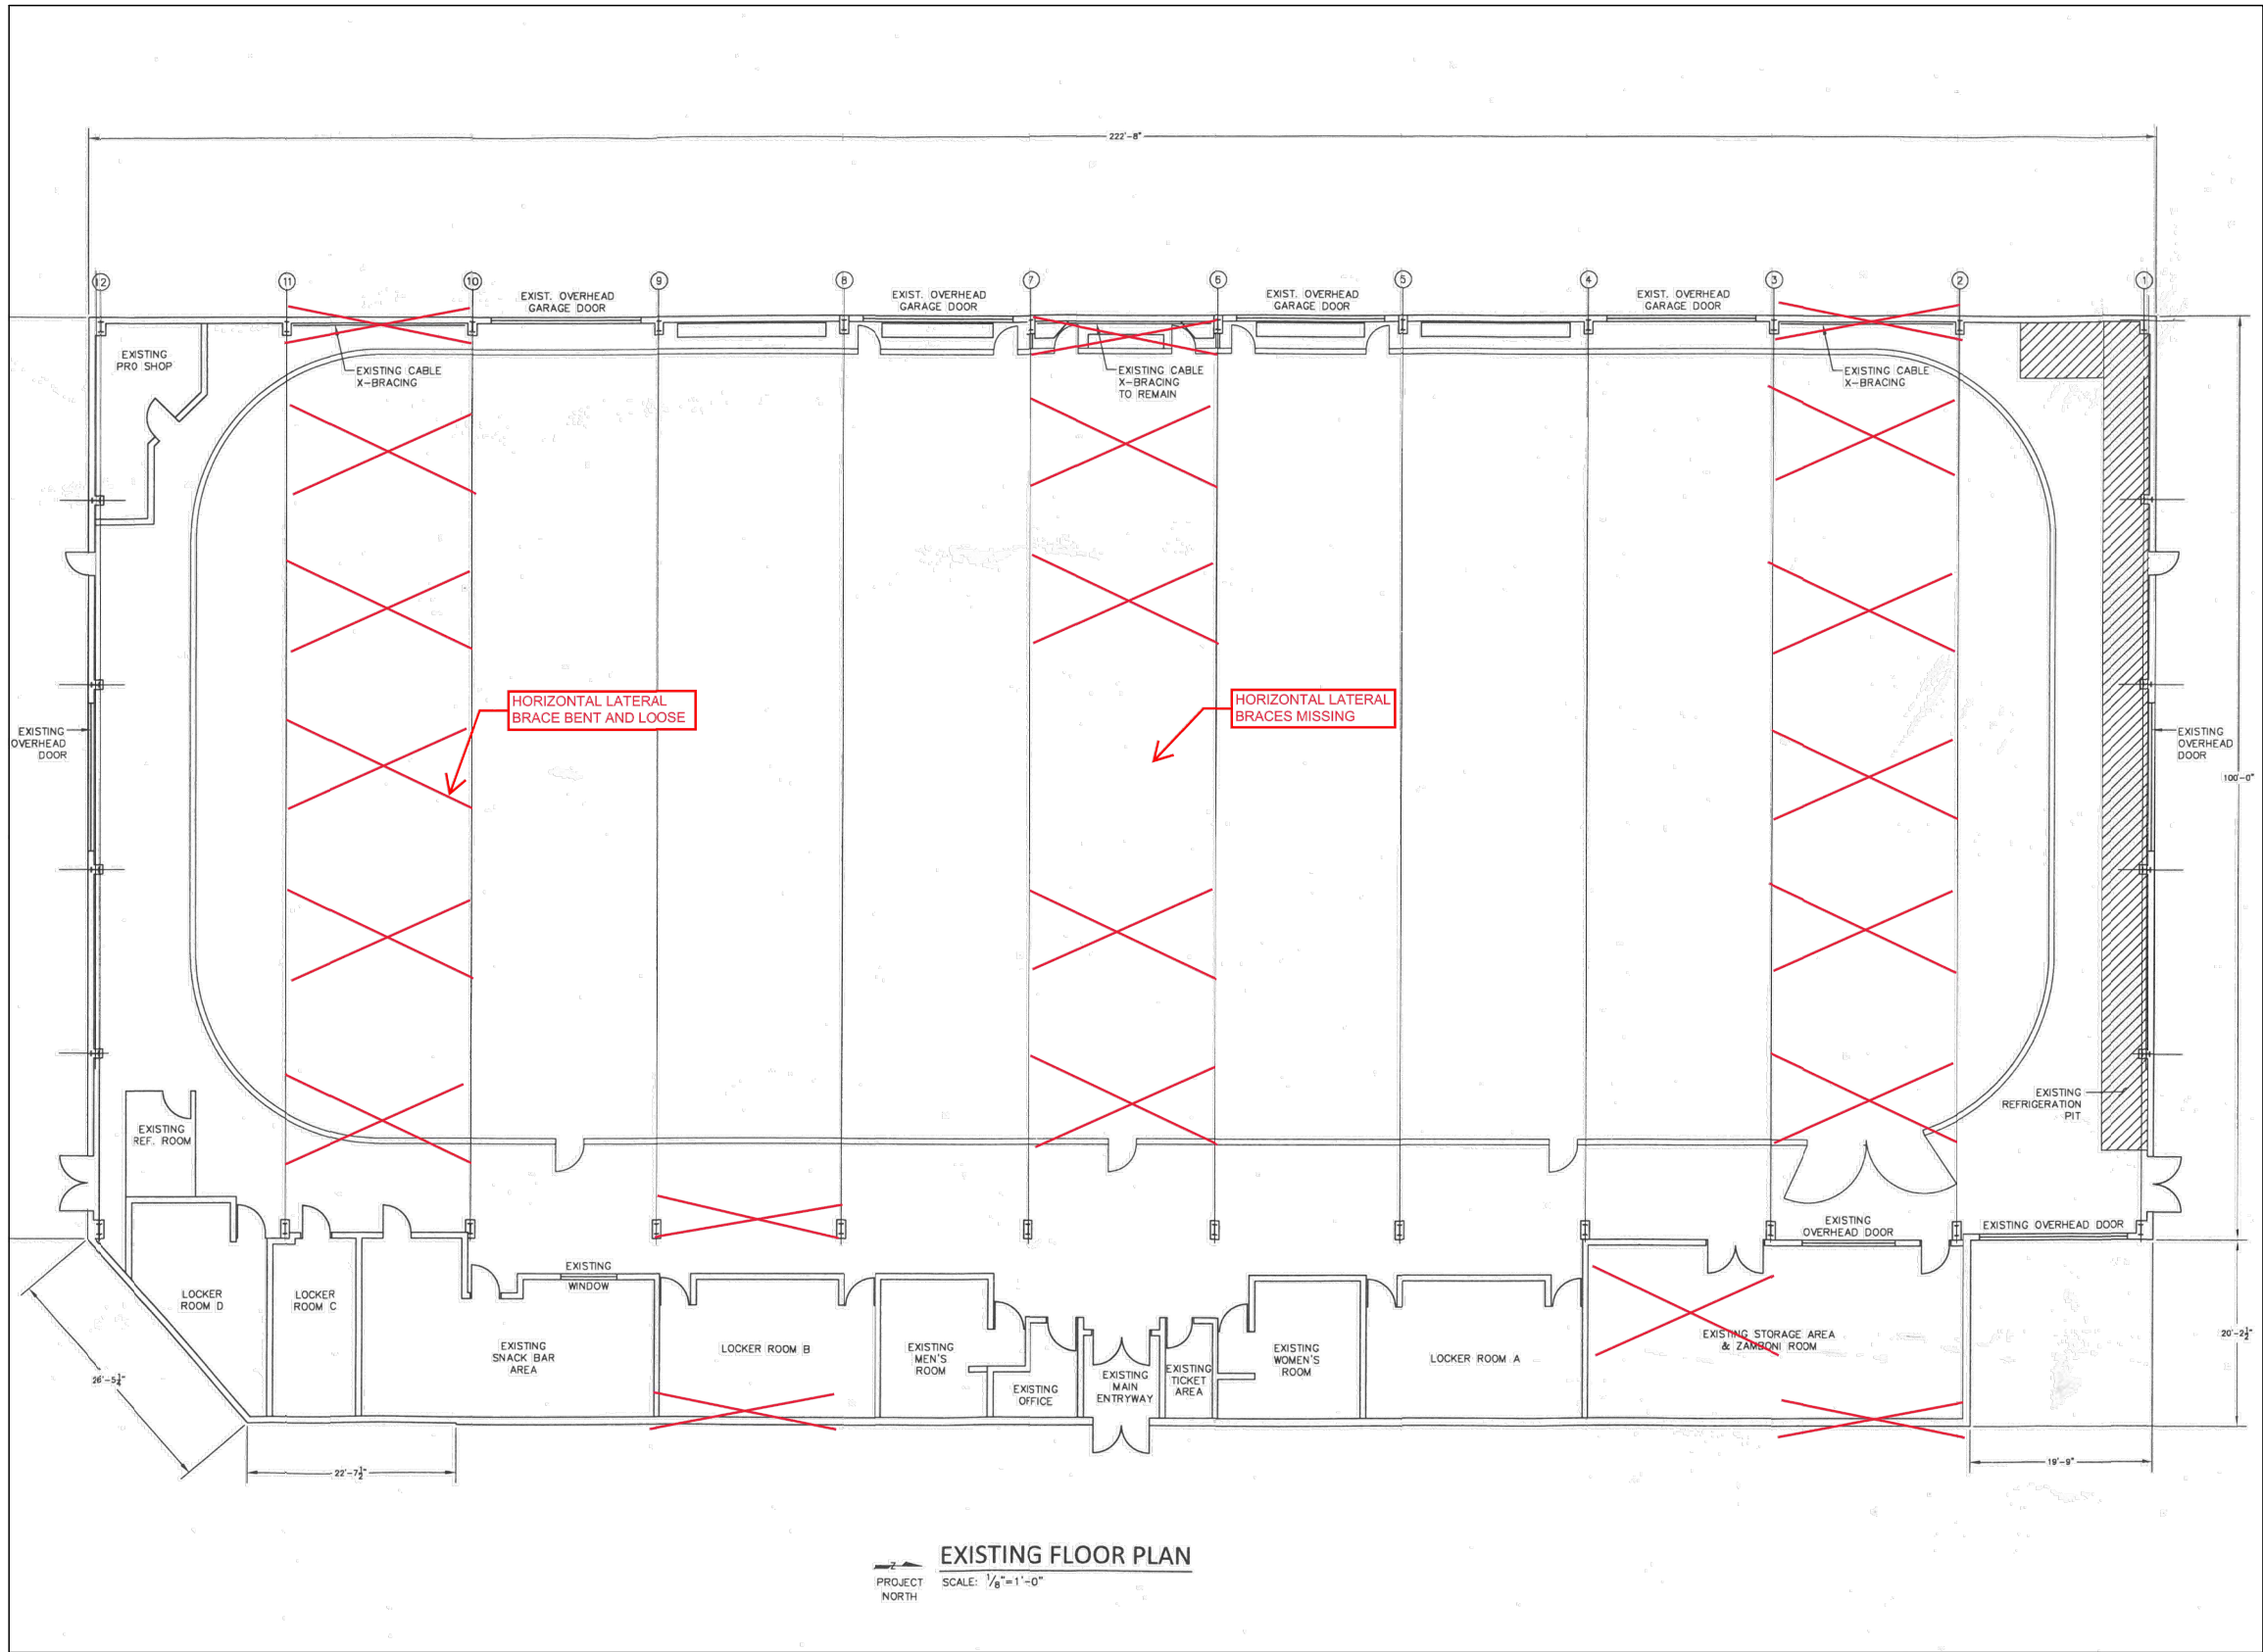
project number: 23020
 drawn by: JMF
 checked by: CJT
 scale: AS NOTED
 date: 18 JULY, 2023
 released for: _____
 sheet description: **LATERAL BRACING SUMMARY**

Throughout the structure there are several rod braces that are intended to provide lateral bracing of the structure when the building is subject to wind or seismic loading. The brace locations are shown on the attached sketch SSK-2. Based upon the visual inspection and subsequent analysis it appears that many of the lateral braces have been moved and/or are damaged.

During our inspection it was noted that in a few places the lateral bracing had been either damaged due to a high wind event or removed. These areas included, between gridlines 6 and 7 at the center of the roof the braces were missing, between gridlines 10 and 11 at the eastern wall the vertical lateral braces were missing and between gridlines 10 and 11 braces were bent, it is recommended that new lateral braces be installed in these areas and any other places where braces are bent. It was also noted that several of the rod braces had slipped out of their hillside washers. All of the rod braces should be adjusted and their hillside washers should be reset.

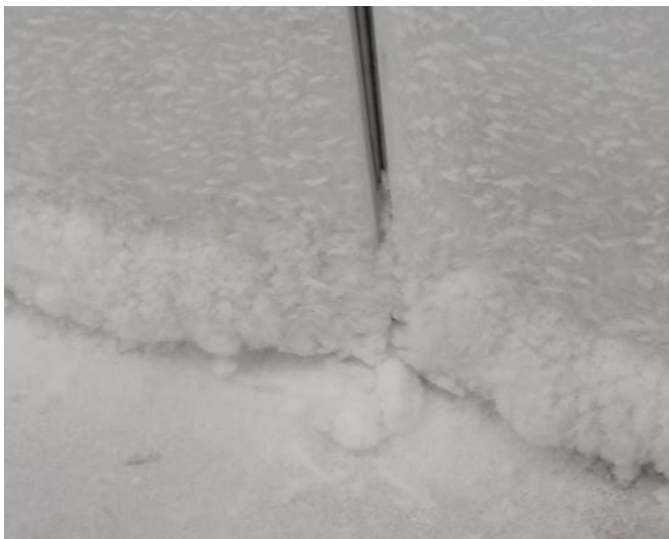
12. Location:

Condensation ice on dashers.

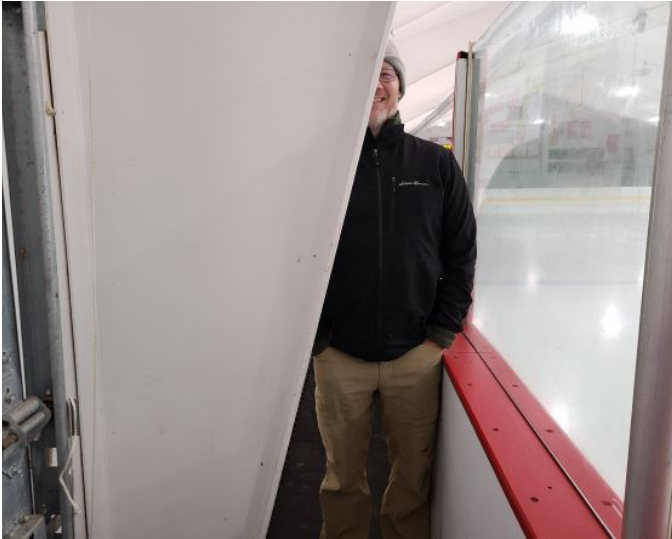
31. Location:

Team bench area - clearance issue.

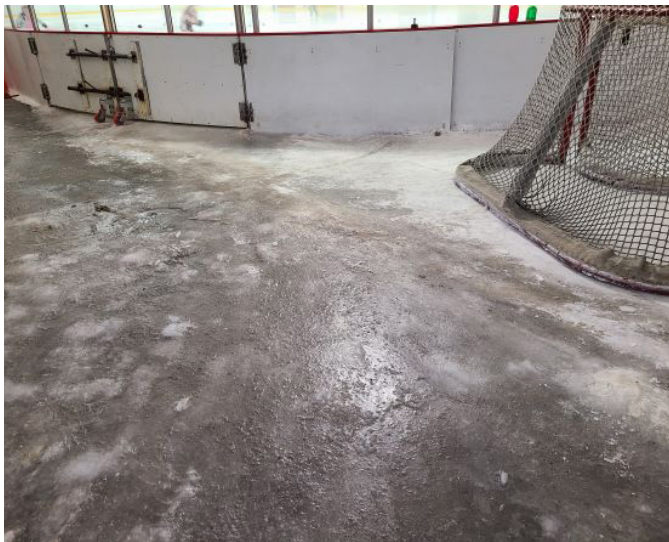
35. Location:

Typical icing at spectator side of gate and dashers.
